# ACCOUNTS AND PAPERS:

RAILWAYS.

16 *January* 1902 — 18 *December* 1902.

I HAVE the honour to present to the Board of Trade a General Report on the accidents that have occurred in the working of the railways of the United Kingdom during the year 1901, founded on returns made by the Railway Companies under the Regulation of Railways Act (34 & 35 Vict. c. 78. s. 6), and on reports upon certain accidents made after inquiry by Officers of this Department.

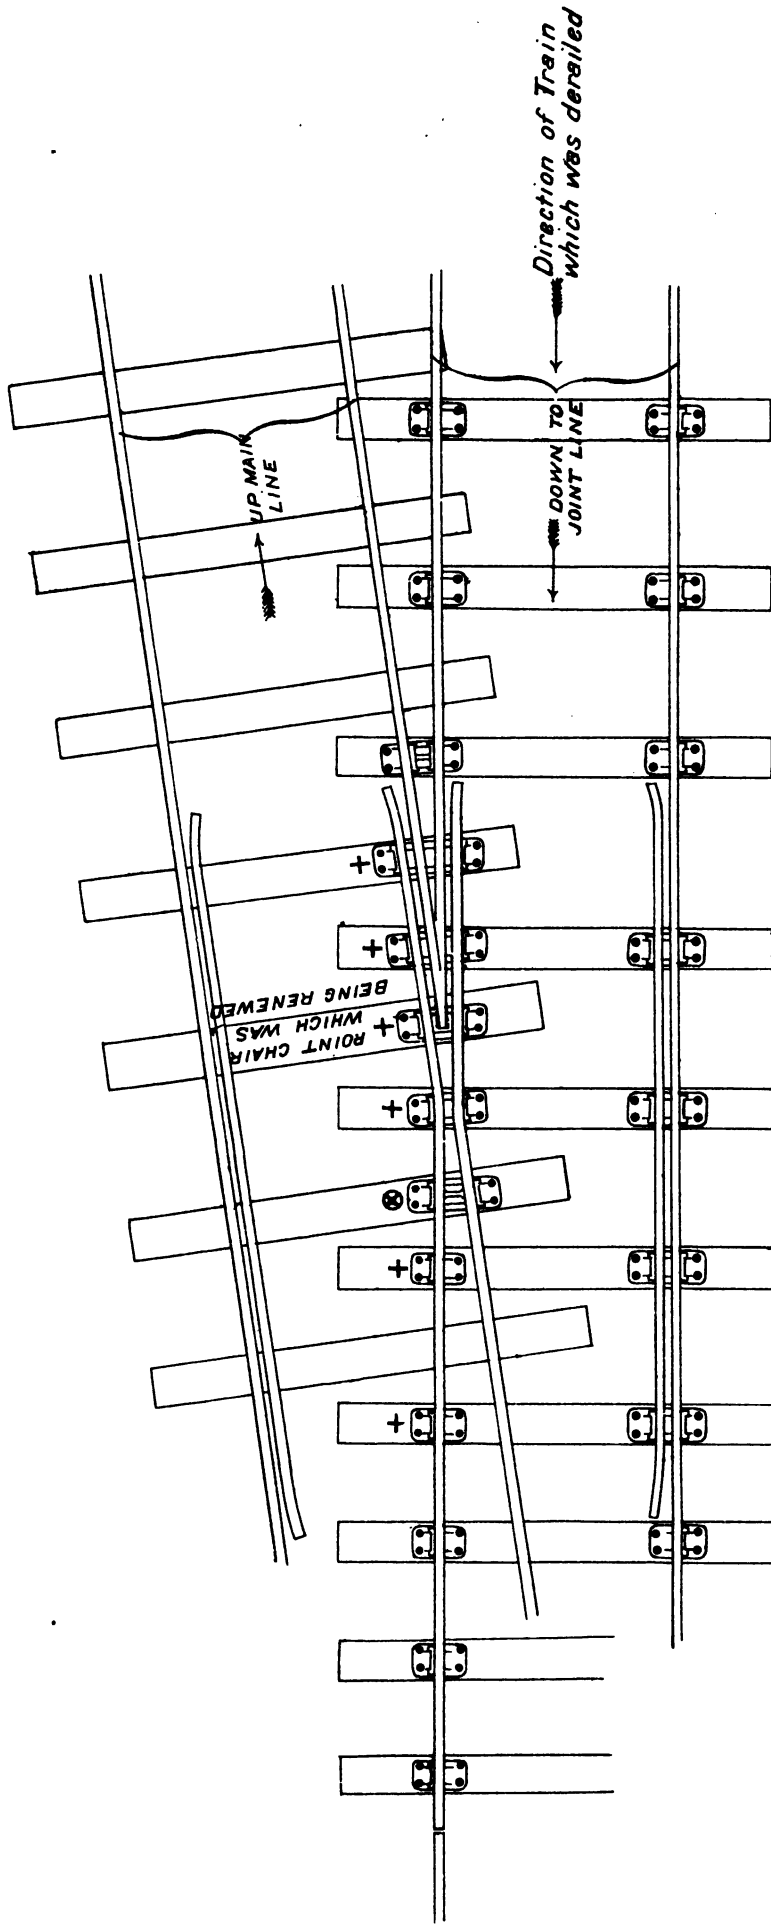
SKETCH OF CROSSING AT KILMARNOCK.  
WHEN ACCIDENT OCCURRED 19<sup>TH</sup> MAY 1902.

NOTE - The Keys were out of the Chairs marked + when the train was passing. The Key of the Chair marked ⊕ was loosely replaced by Foreman Ferry and came out when Train was passing over.
